DART AEROSPACE LTD	Work Order:	22761
Description: Console Side LH (206 Hi-Slope)	Part Number:	D2602-1
Note: Issue with Part Number D2602-2		
Dwg: D2602 Rev. A1	Qty:	17 20
		Page 1 of 1

DESIGN	DRAWN BY	DART AEROSPACE LTD VICTORIA INTERNATIONAL AIRPORT, CANADA	
CHECKED KE	APPROVED Bw	DRAWING NO. D2602	REV. A
DATE 97.10.22		TITLE CONSOLE SIDE	SHEET 1 OF 1
			SCALE 1:4
A	97.10.22	D2602 WAS D206-547-21/	
AI	32.06.04	ADD FINISH

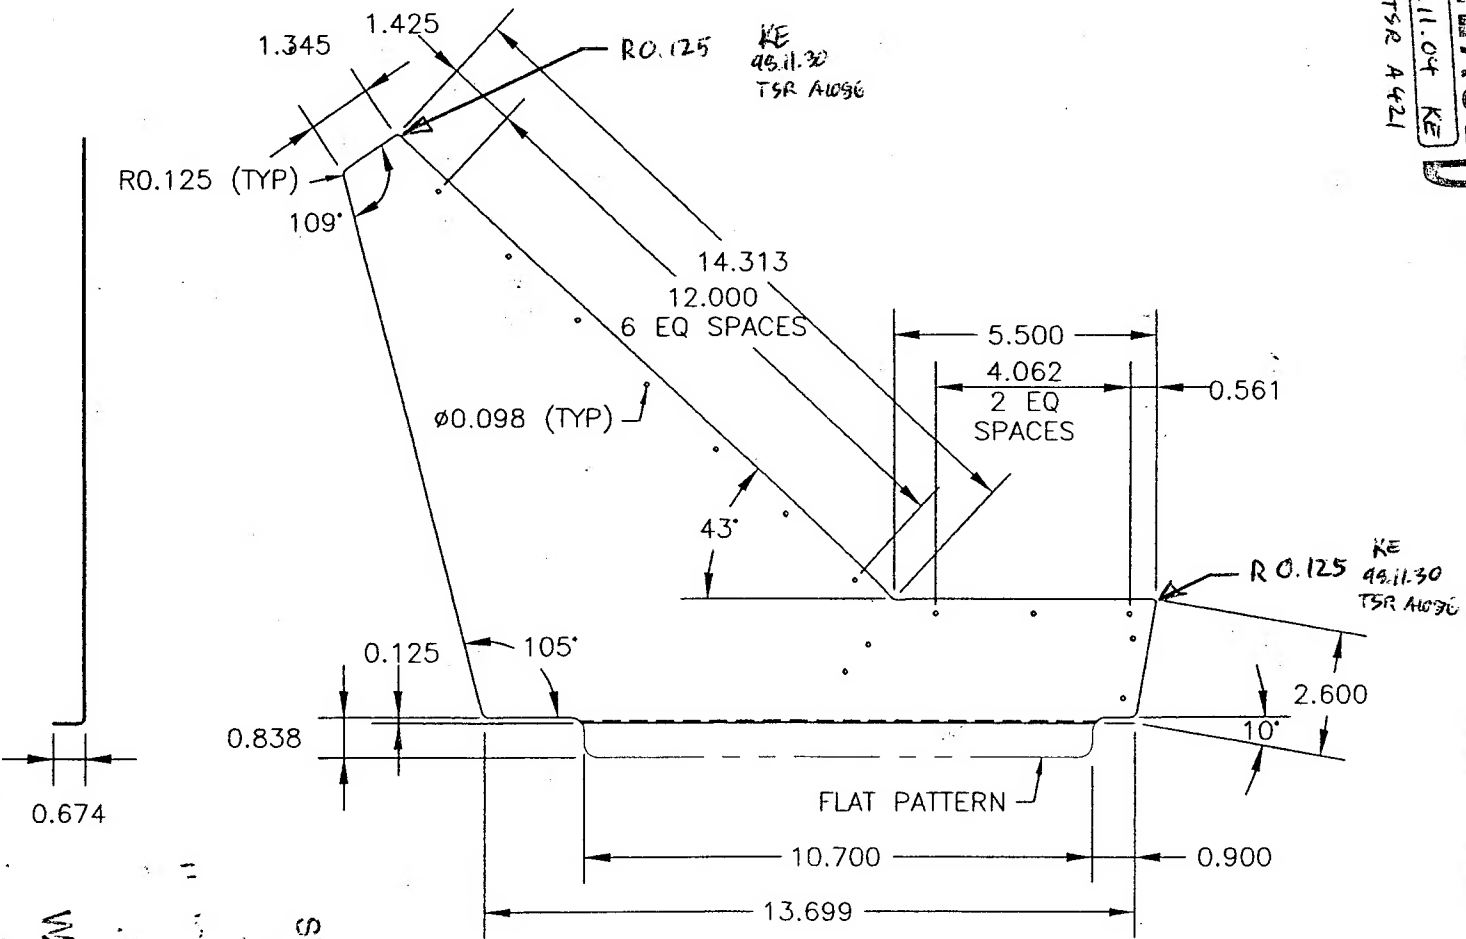
NCR: 22761		WORK ORDER NON-CONFORMANCE (NCR)						
DATE	STEP	Description of NC Section A	Corrective Action Section B			Verification Section C	Approval Design Mgr	Approval QC Inspector
			Initial Design Mgr	Action Description Design Mgr	Sign & Date			
02.06.04	3	0.838" DIMENSION UNDER TOLERANCE ON SOME PARTS BY UP TO 0.030"	CP	WHEN BENDING? PAIR-UP SIMILAR PARTS & MAINTAIN 0.674" FLANGE DIMENSION.	 05/01/18 SB	 05/01/18	 per asmt	 05/01/18
05/04/12	7	1 part was scrap Band over tolerance	 per asmt	destroy	SB 05/04/13	 05/04/13	 per asmt	 05/04/13

The big question is what happened. Looks like something shifted or lifted up on the HAAS to me.

Having said that, I believe you and I agree that the parts could be salvaged (if this is more cost effective) by bending them in pairs (one left and one right) and preserving the width of the tab as much as possible (reduce console height slightly, but left MUST match right).

If you decide to salvage, you can use this email as my acceptance of the deviation and attach to WO.
